**U.S. ENVIRONMENTAL PROTECTION AGENCY  
REGION 5**

**CWA OVERSIGHT INSPECTION REPORT  
ILLINOIS**

<b>Inspection facility</b>	Hollis Shafer Swine Farm 785 North Taylor Lane Astoria, Illinois 61501
<b>NPDES permit status</b>	No permit
<b>IEPA inspection date</b>	04/16/12
<b>EPA inspection date</b>	09/14/12

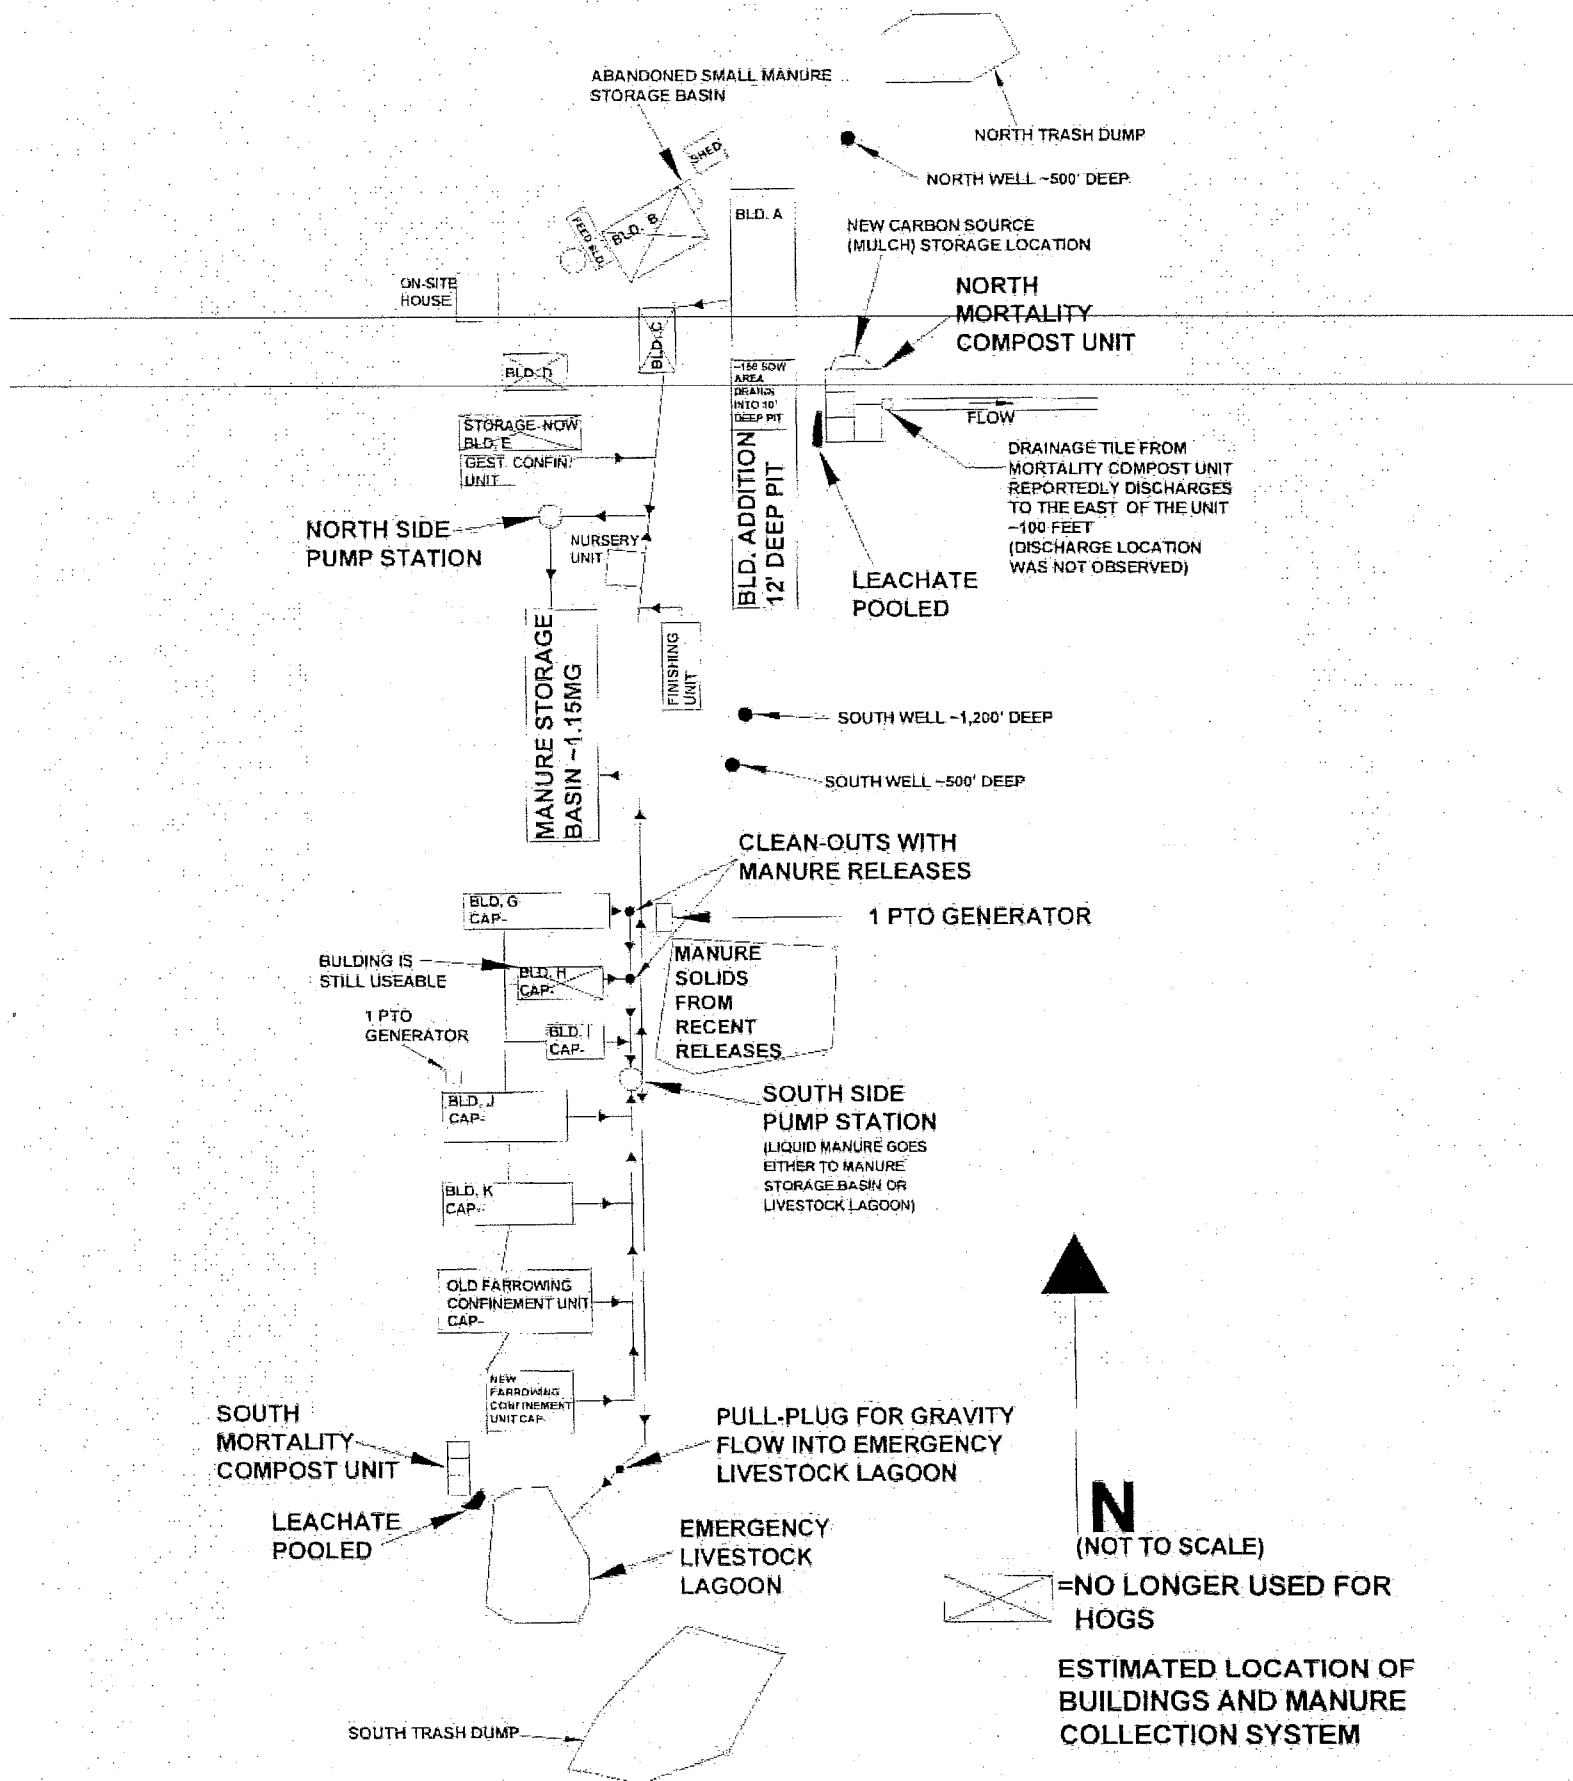
Figure 3. Diagram of Hollis Shafer Swine Farm near Astoria in Fulton County On April 16, 2012.

side of the facility was reported to be vacant at this time, but does have the capability to produce hogs. Building E on the north side of the site has been converted into a storage building. Three other total confinement buildings were reported as being vacant and not in service at this time. During the inspection only 10 of the 15 total confinement buildings were being used. For visual of the site see Figure 3.

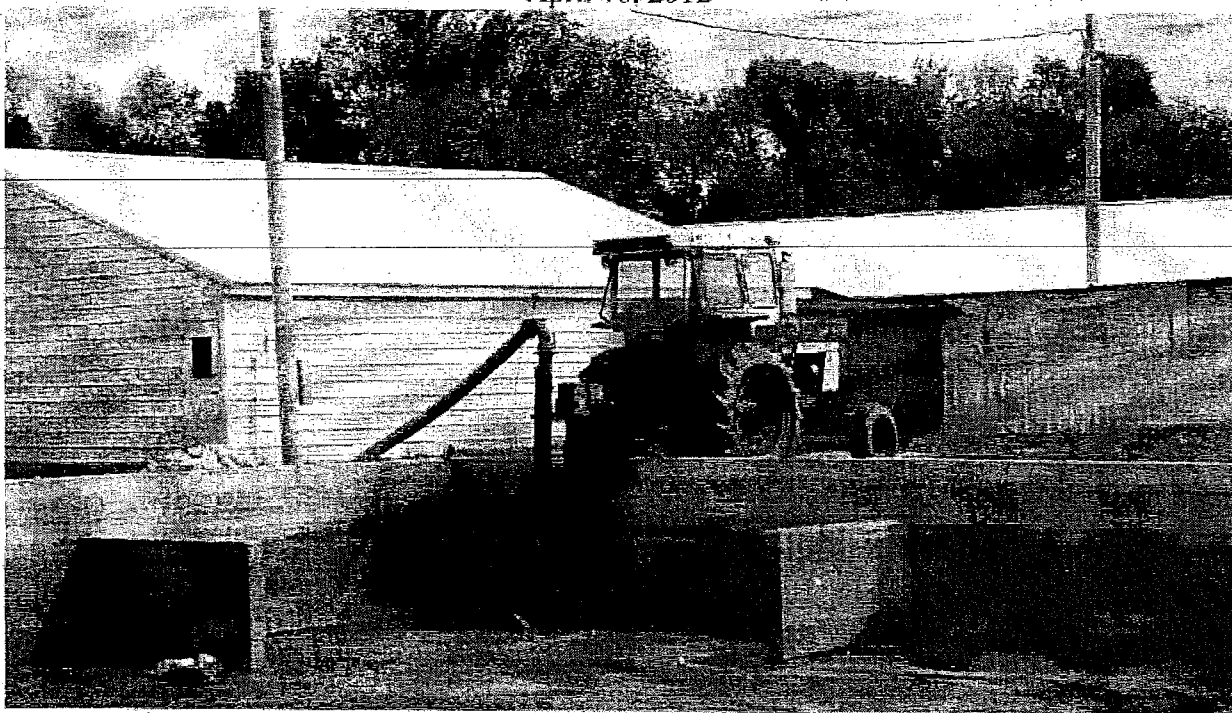
Photograph #3. Recent liquid manure removal from the Manure Storage Basin has occurred.

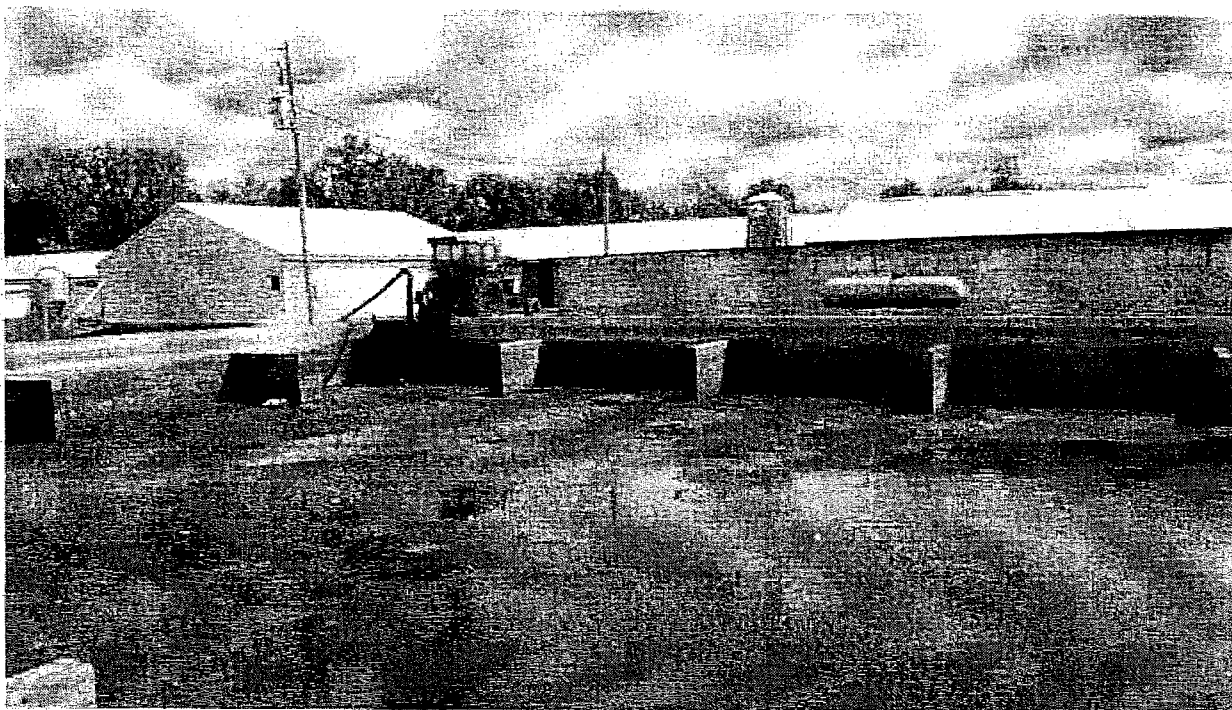
Photograph #4. Manure Storage Basin with manure solids shown.

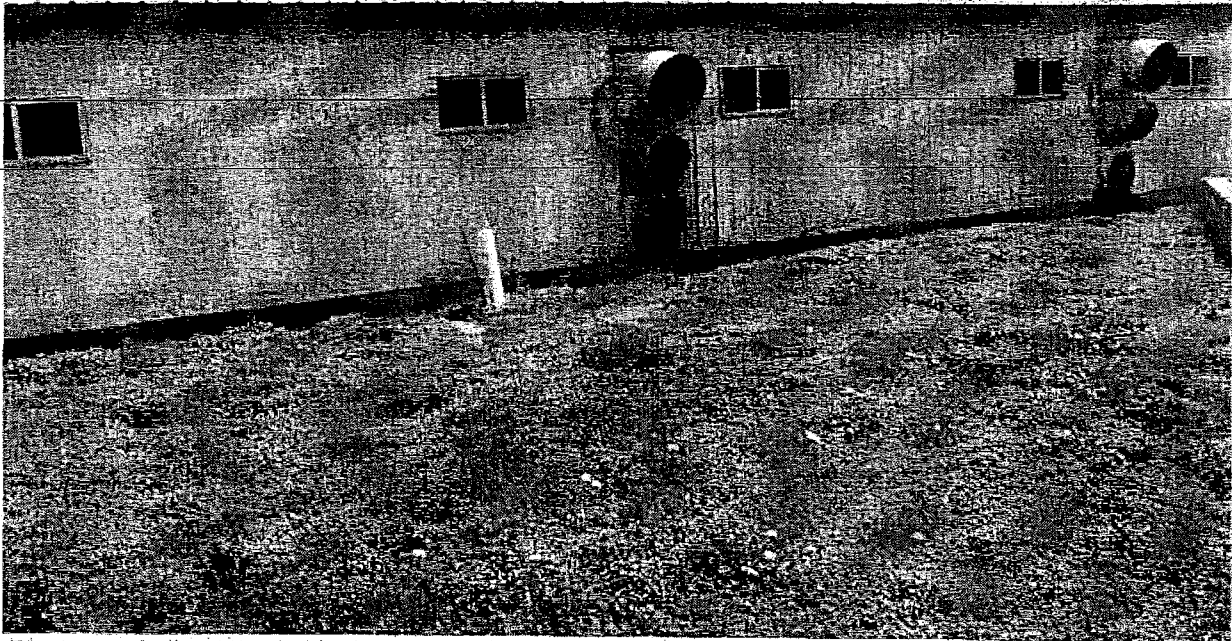
Photograph #7. Tile inlet riser located to the east of the abandoned small manure storage basin.

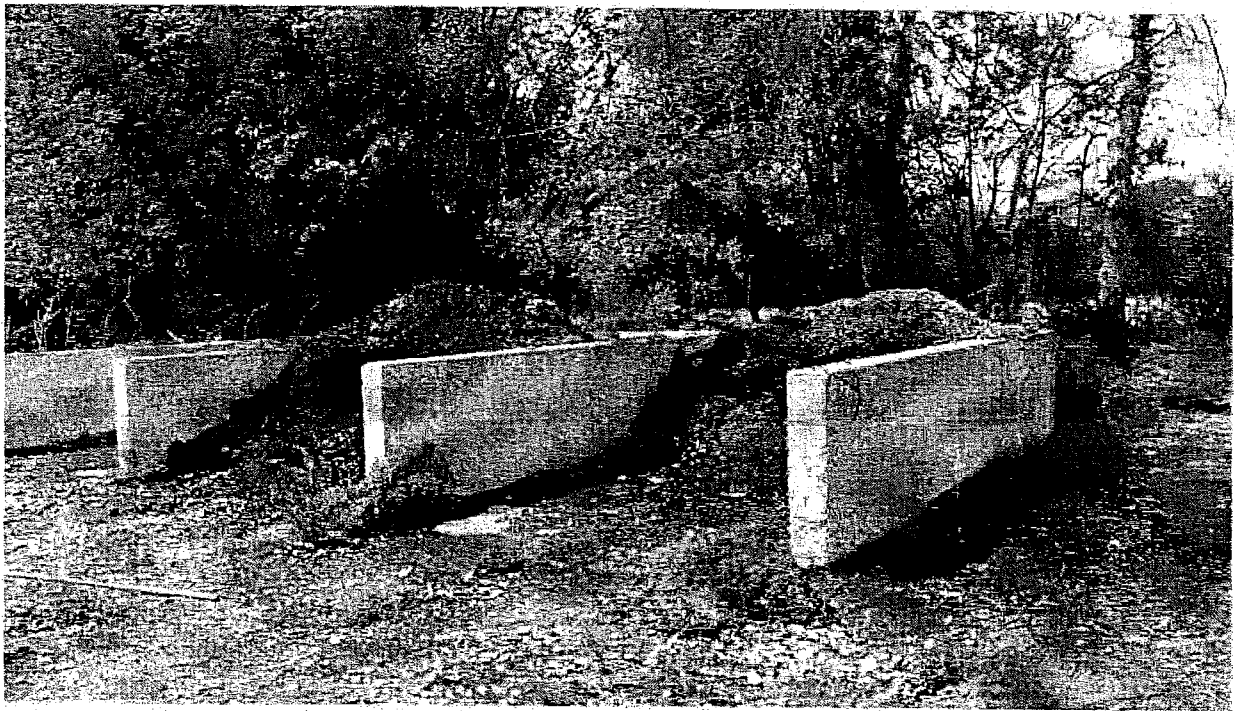
This compost unit was observed with leachate pooling near the composter. There did not appear to be enough carbon source (mulch), and the carbon source being used appeared to have a high moisture content. There was no thermometer or temperature readings being taken. See Photographs #8-#11.

Photograph #8. The South Mortality Compost Unit.

- d. Proper cover should be established for both mortality compost units.
  - e. Proper carbon source should be used; this will help maintain proper moisture content. A few examples of proper carbon sources are: coarse sawmill sawdust, shredded corn stalks, chopped straw, coarse-ground corn cobs.

- f. The mortality compost units should be covered to help maintain proper moisture content.
  - g. Proper records of mortalities should be maintained.

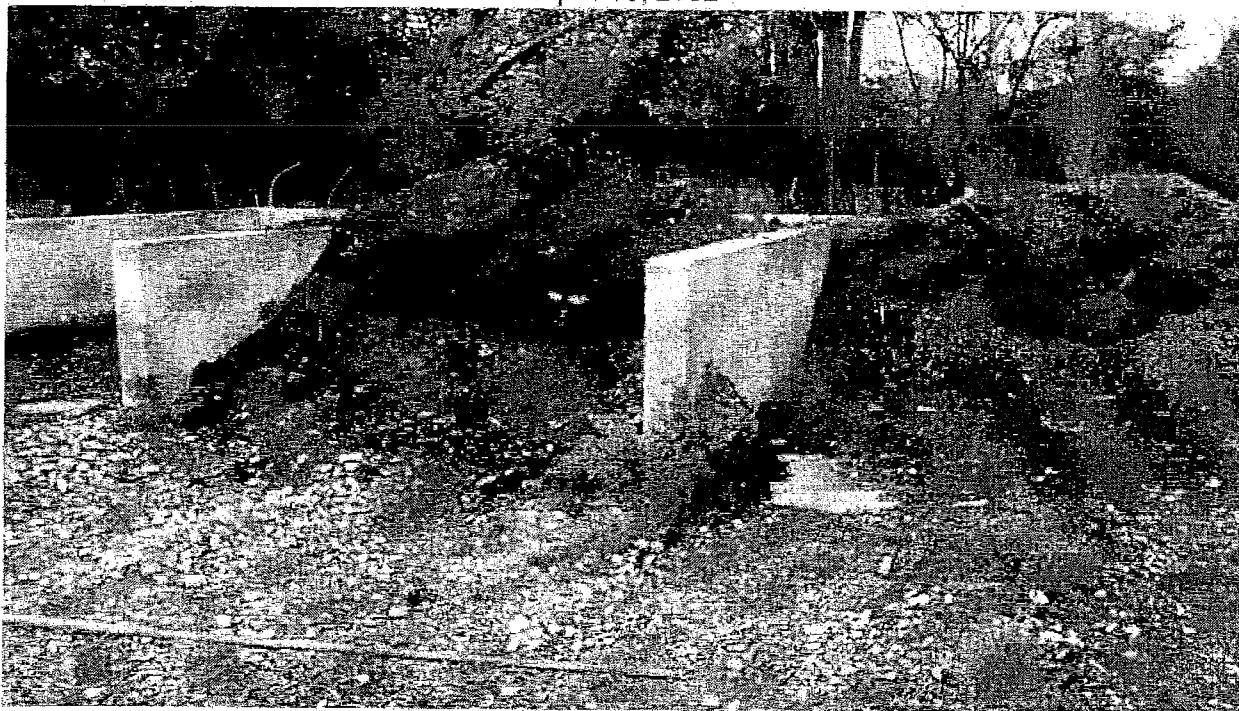
Photograph #9. Three bins of South Mortality Compost Unit.

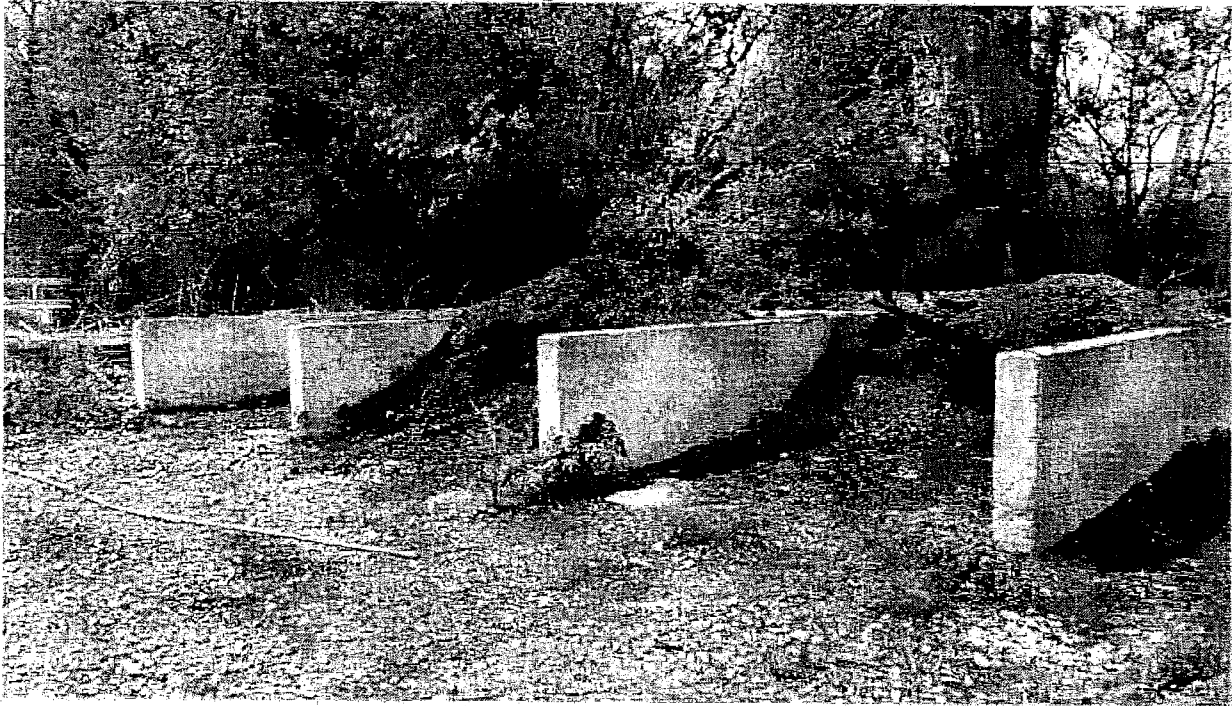
Photograph #11. South Mortality Compost Unit.

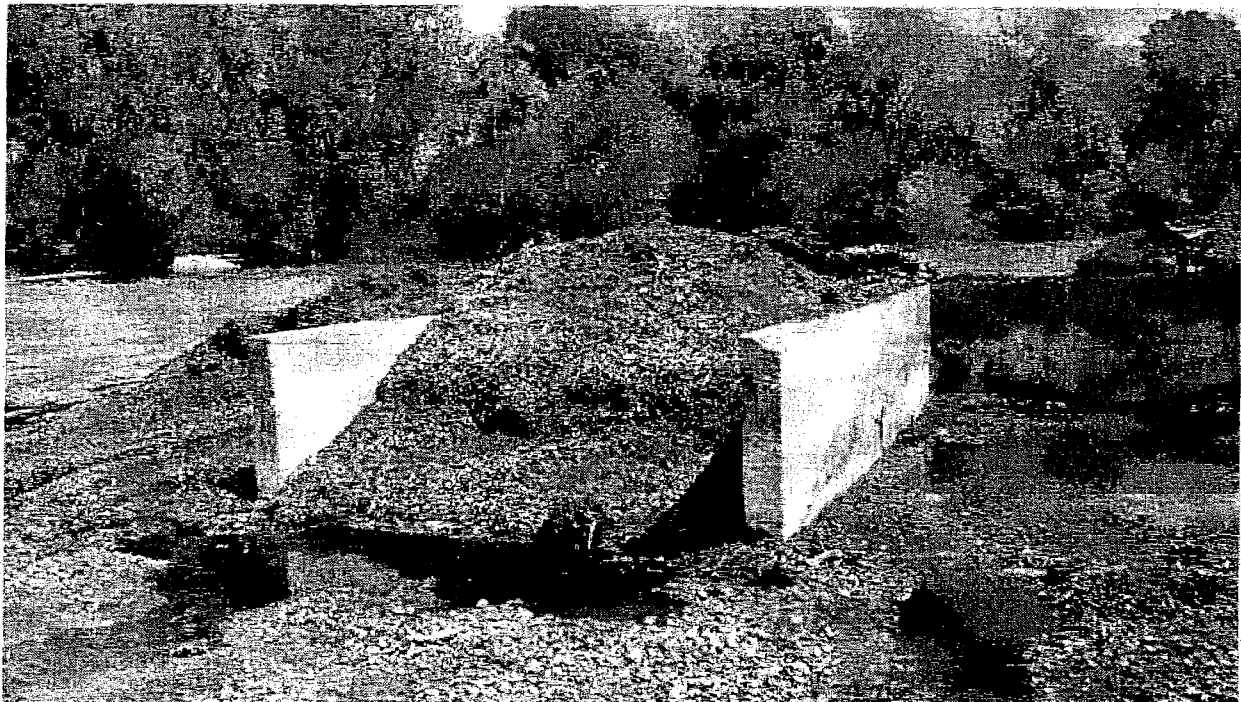
Very dark colored and odorous leachate was observed being released from both side of this mortality compost unit. There were multiple bones observed not being properly covered. There were also sow carcasses exposed. See Photographs #13-#18.

Photograph #14. Northwest bay of the North Mortality Compost Unit.

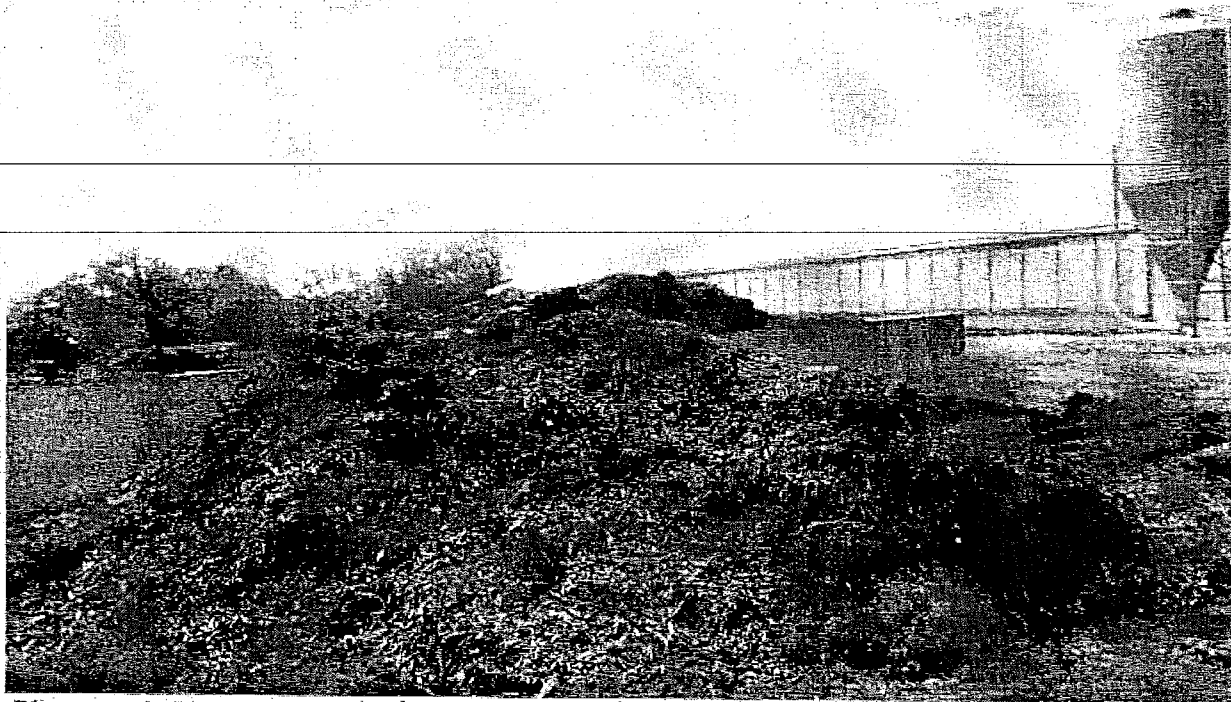
Photograph #15. On the north side of the north compost unit the carbon source (mulch) is kept.

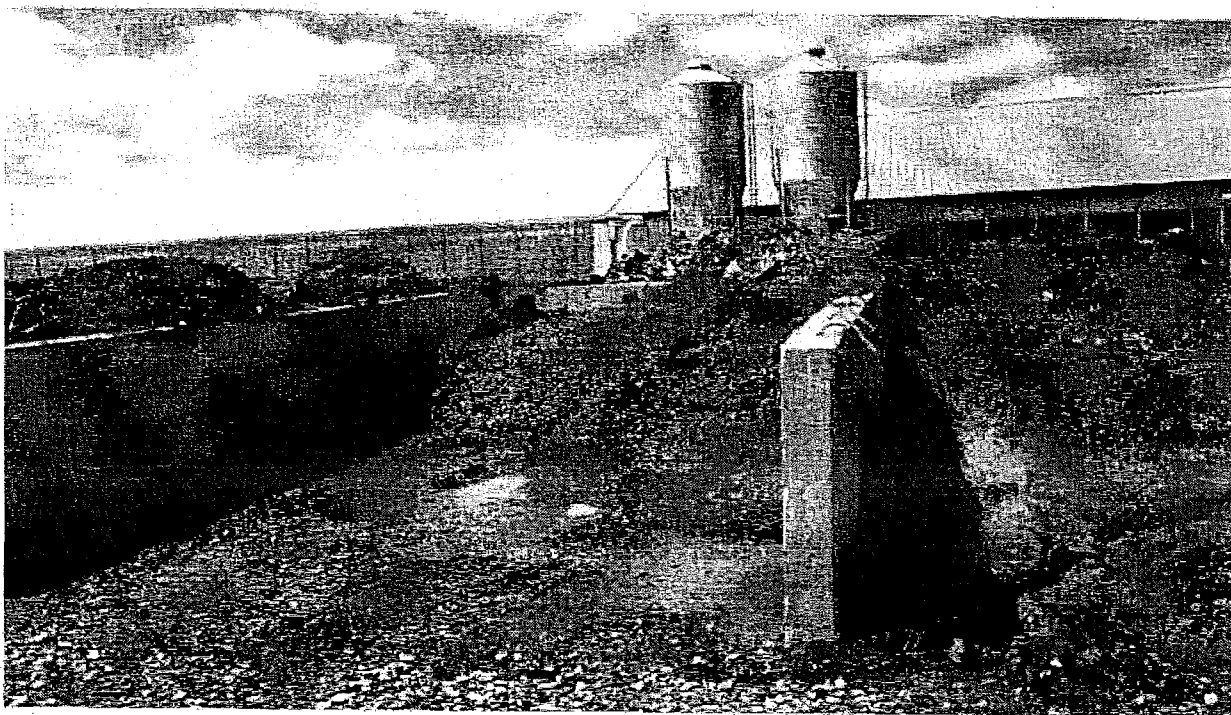
Photograph #16. Northeast bay of the north compost unit.

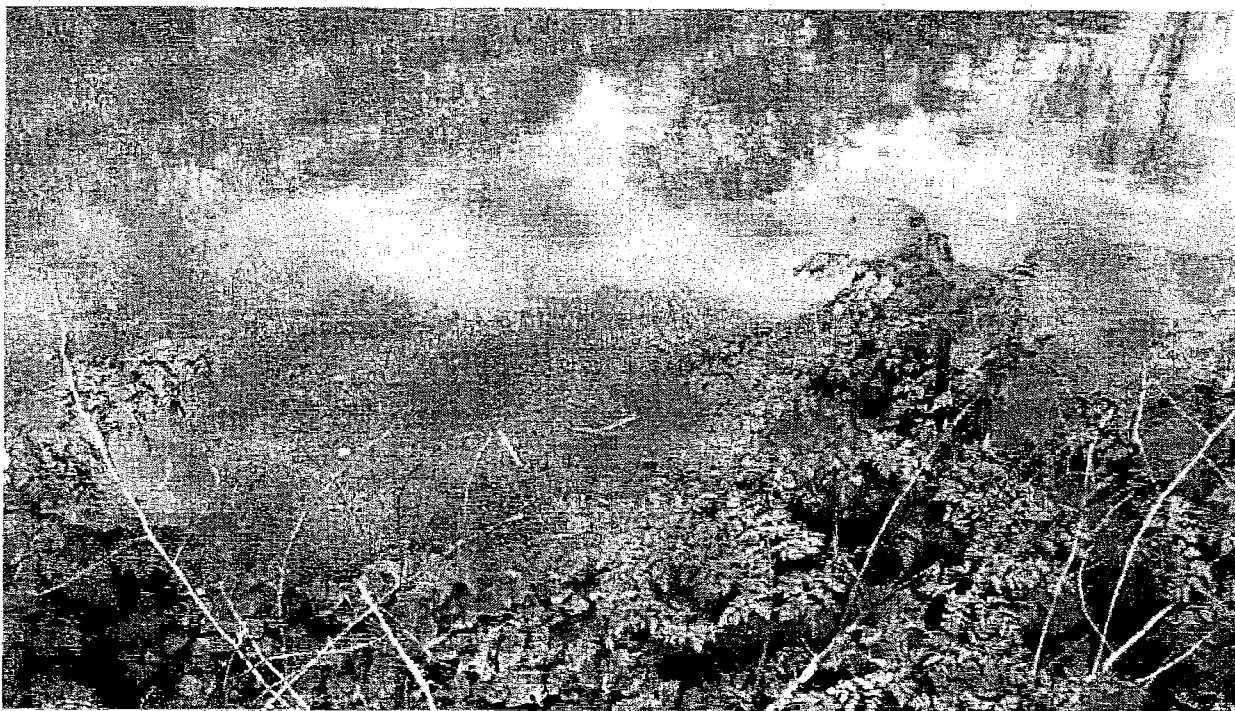
Photograph #22. Close-up of liquid in the Livestock Lagoon.

- b. Liquid manure should be removed to attain at all times a minimum of 2 feet of freeboard.
  - c. The integrity of the berms should be properly evaluated, with any found problems with the berms properly addressed.

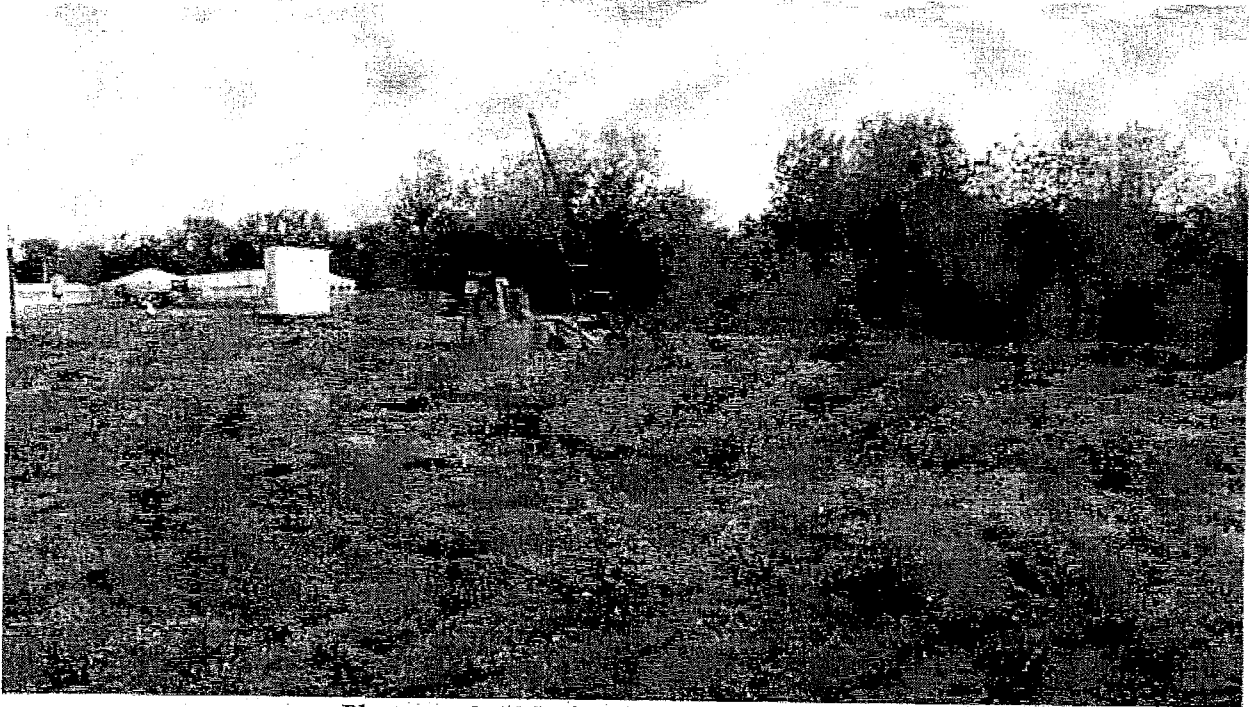
Photograph #25. South Side Pump Station.

3. South Side Pump Station is not working due to the impeller being damaged. This lead to manure overflowing and becoming released from the pump station. This pump station should be fixed immediately. All the manure solids near the pump station from the liquid manure releases should be removed and properly land applied.

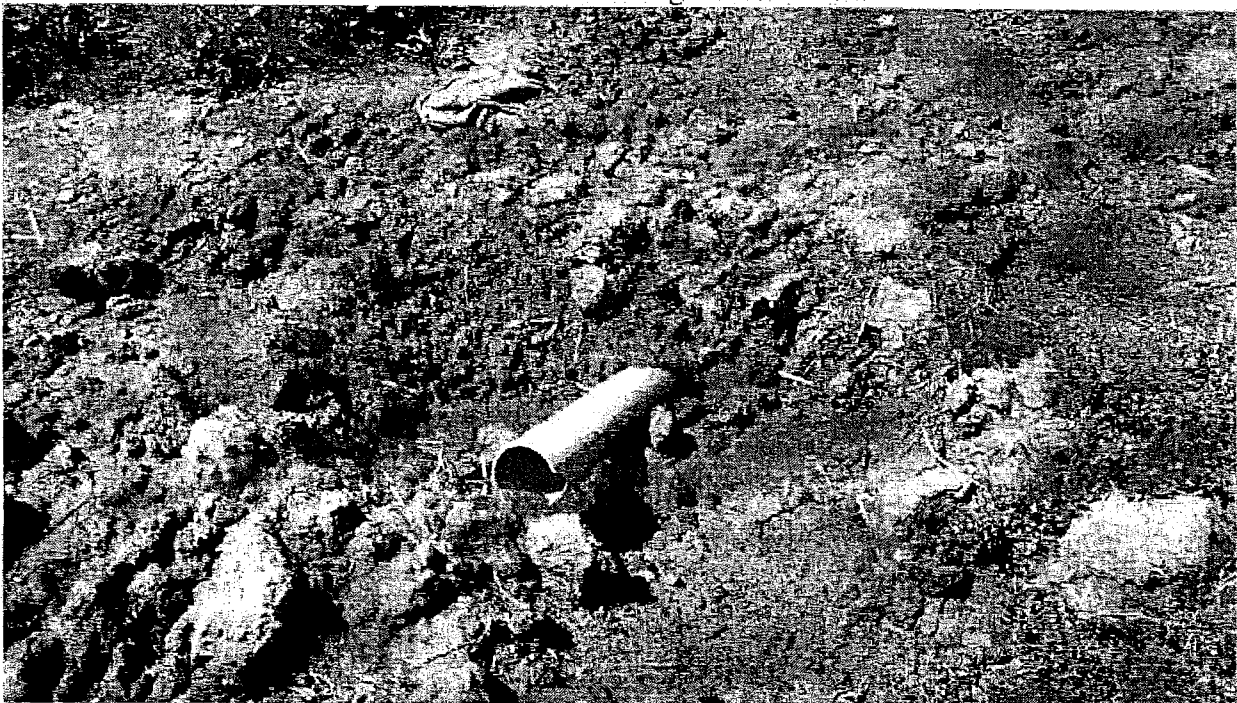
Pipelines from buildings pull plug system are releasing manure from cleanouts where the building's pipeline enters the main pipeline into the South Side Pump Station. These manure releases were contributed to low clean-outs and the manure becoming plugged in the system. This has occurred at two locations so far: Building G and Building H. Mr. Cooper dug up the pipelines and created taller cleanouts to help prevent future manure releases from the manure back-ups. The buildings manure drain lines are believed to enter the manure collection mainline at a 90° angle. See Figure 3 for diagram of facility's manure collection system with estimated locations of clean-outs with recent manure releases.

Photograph #32. Building G clean-out pipe recently extended after the clean-out had manure release occur. This clean-out pipe still does not appear to be at the correct elevation to prevent another manure release.

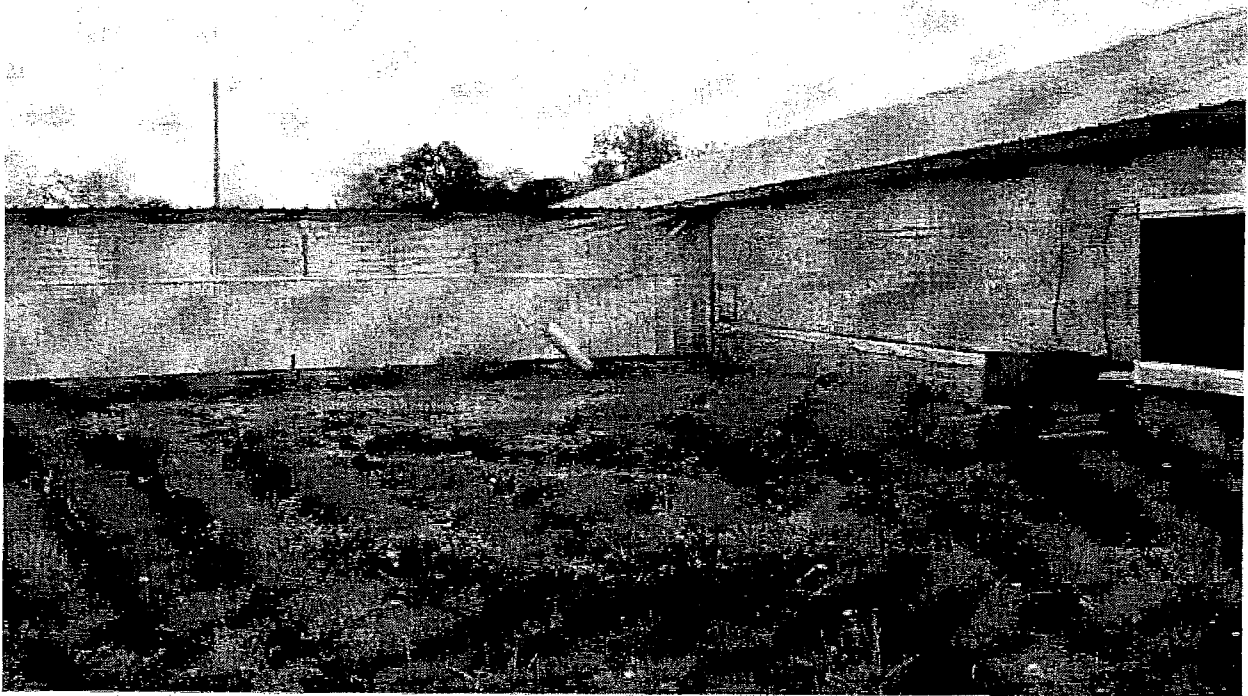
Photograph #33. Recently extended clean-out on the south-west side of the site.

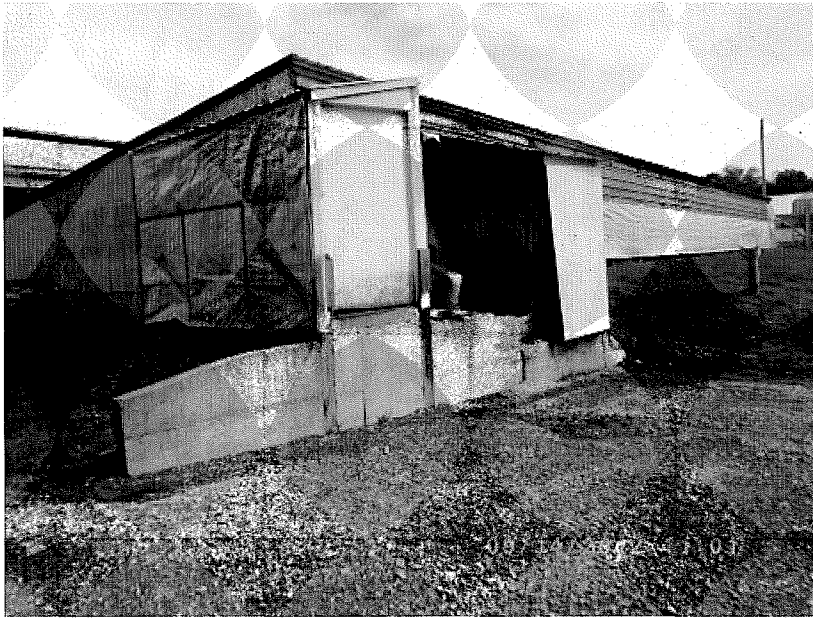
Location: Southwest corner of Gestation Building E

Mr. Wittig stated that during a large precipitation event in early September, caused by the remnants of Hurricane Isaac, the barn pit for Gestation Building E had overflowed onto the ground. Mr. Wittig referred to the event as a “washout”. During the overflow of the pit beneath Gestation Building E, the manure was carried with the storm water to the intermittent unnamed tributary of Sugar Creek.

IMGP1551: Load in/out for Gestation Building E. A “washout” of manure from this building entered a storm water pathway. Manure solids are still visible around the barn entrance.

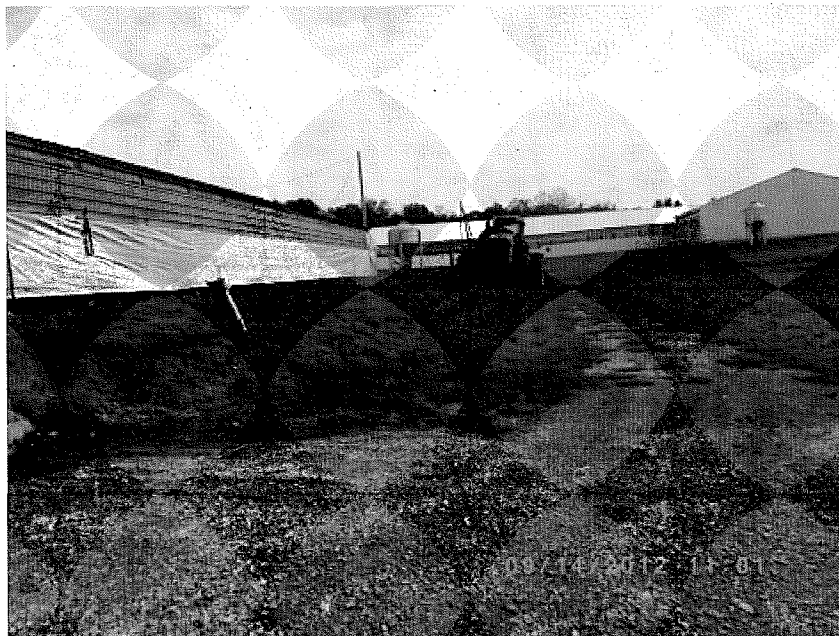
Location: Southwest of Gestation Building E

The two culvert pipes under the swine walkway conveyed storm water flow into the yard. The storm water flowed along the surface south and then flowed west where it accessed a culvert under Taylor Lane. The culvert discharged storm water on the west side of Taylor Lane into a gully which led to the intermittent unnamed tributary of Sugar Creek west of the facility.

IMGP1552: Storm water from north of the Gestation D and E Buildings flows through the yard to a culvert under Taylor Lane. The manure that washed out from Gestation Building E would be transported with the storm water.

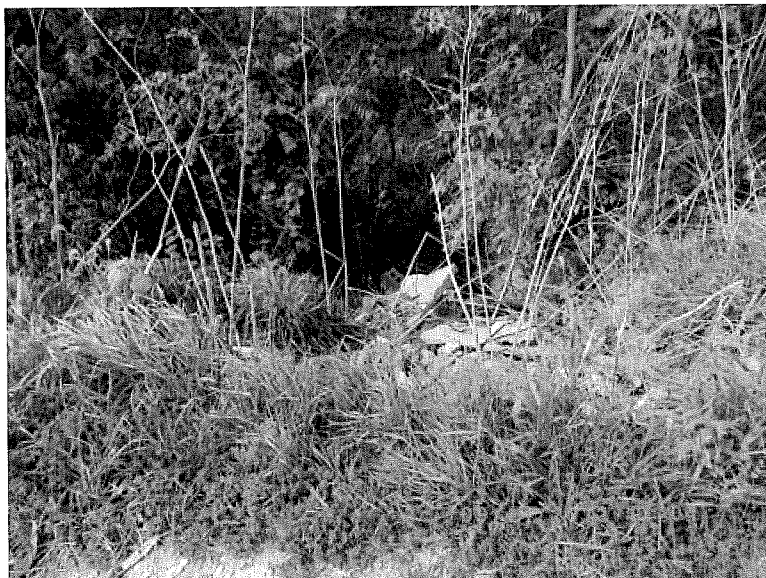
Location: Along Taylor Lane

IMGP1555: Outlet of culvert under Taylor Lane to storm water gully on west side of Taylor Lane. Gully transports flow to the intermittent unnamed tributary on the west side of the facility.

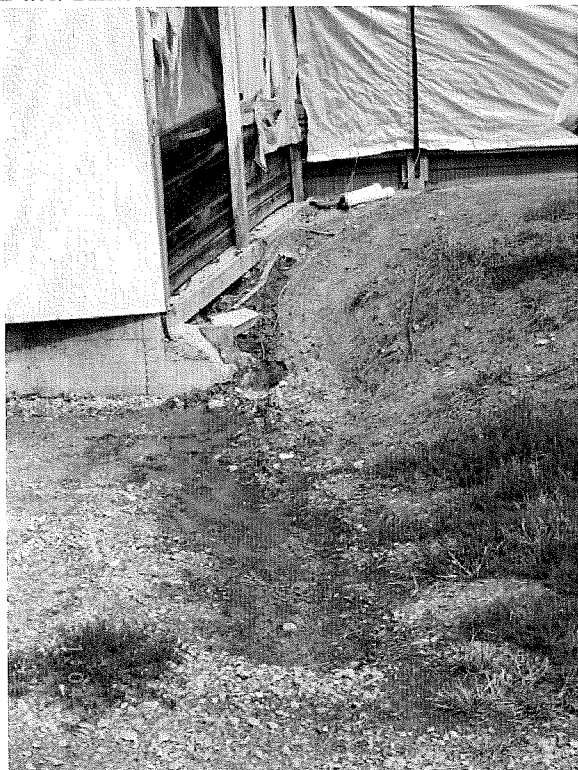
Location: Southwest corner of Gestation Building E

IMGP1556: Manure solids on ground near southwest corner of Gestation Building E.

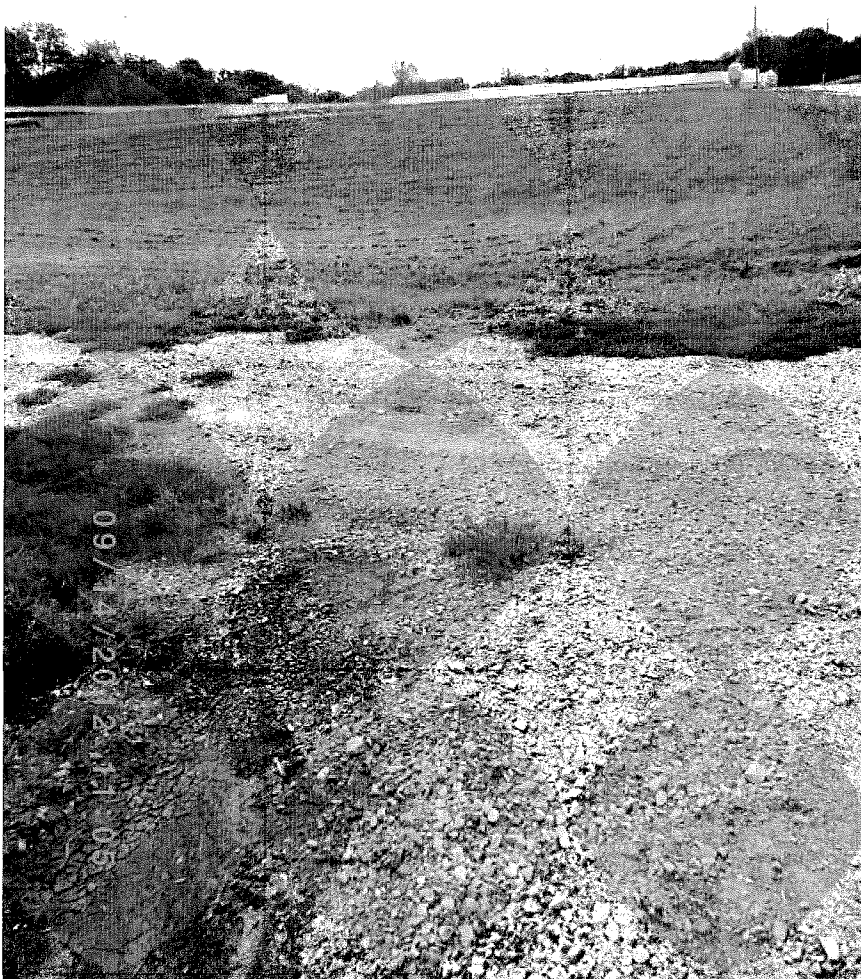
Location: Southwest corner of Gestation Building E

IMGPI557: Manure solids on the ground by Gestation Building E from a “washout” of the barn pit.

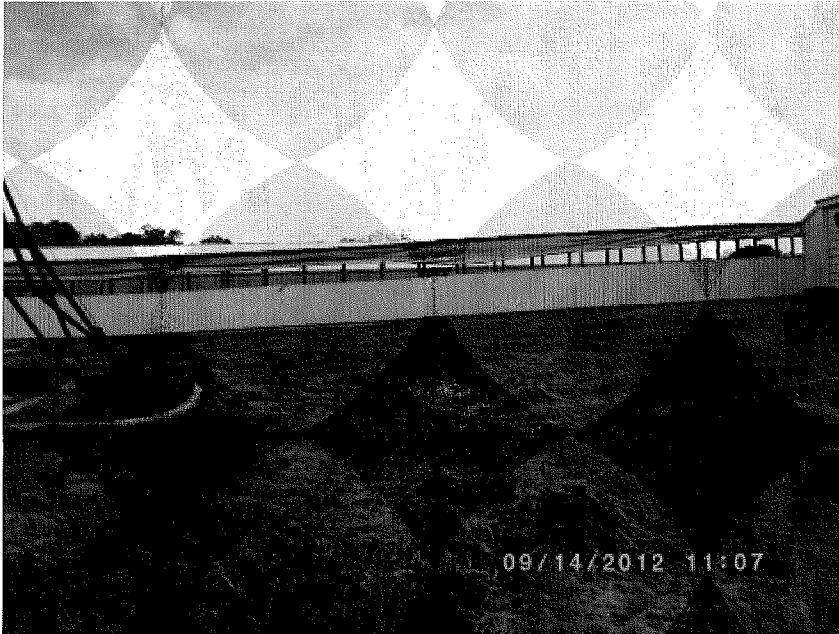
Location: In the yard north of Nursery Building

The ground around the North Pump Station was denuded of vegetation and manure solids remained on the ground around the pump station from when facility personnel needed to replace the broken pump. The old broken pump was still lying on the ground nearby. Storm water would be able to transport the manure solids to the storm water pathway and then to the intermittent unnamed tributary to the west via the culvert under Taylor Lane.

IMGP1560: Ground around the North Pump Station has denuded areas and manure solids on the ground.

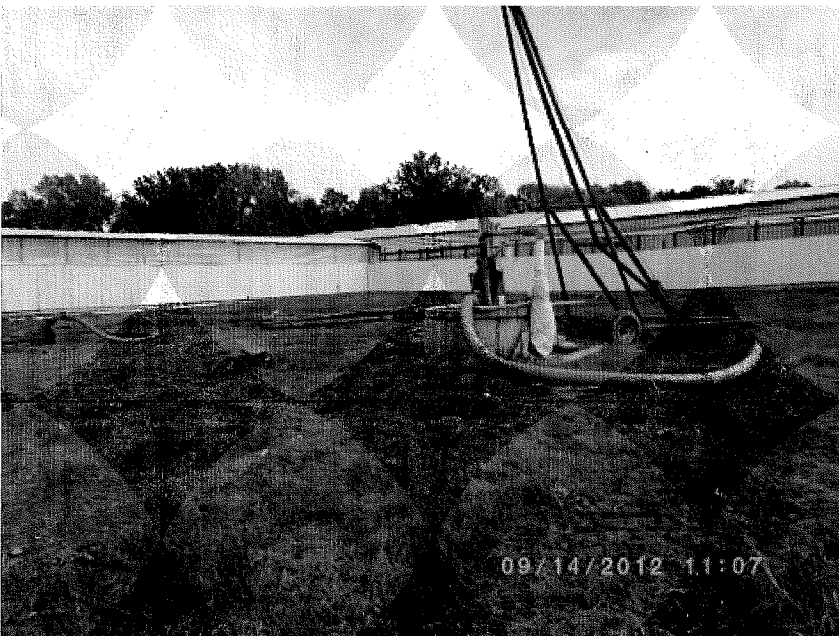
Location: In the yard north of the Nursery Building

IMGP1561: North Pump Station in yard south of Gestation Building E has manure solids around it. A new pump has recently been installed. North Pump Station takes manure from north buildings and pumps it to the Concrete Pit.

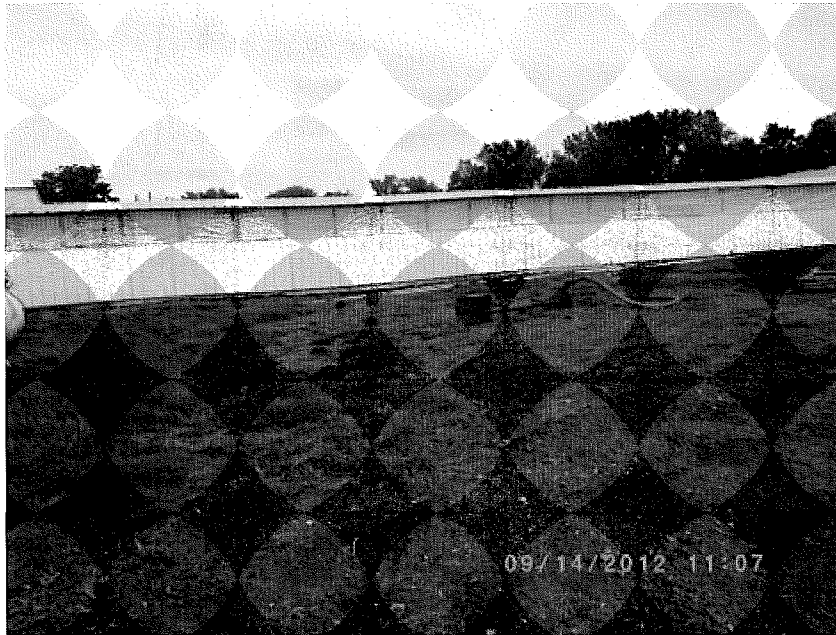
Location: In the yard north of the Nursery Building

IMGP1562: Culvert pipe for storm water under the north/south portion of the swine walkway conveys storm water from the east side of the walkway. Denuded area in yard around the North Pump Station and manure solids are visible on the ground.

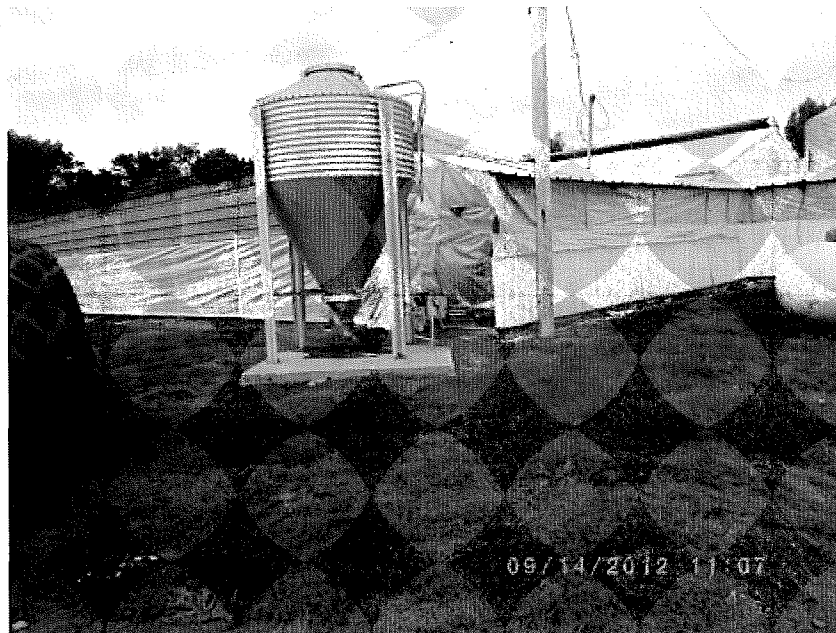
Location: In the yard south of Gestation Building E

Feed was observed on the ground under the feed bins by the Nursery and under several other feed bins at the facility.

IMGP1563: Feed on concrete pad under feed bin.

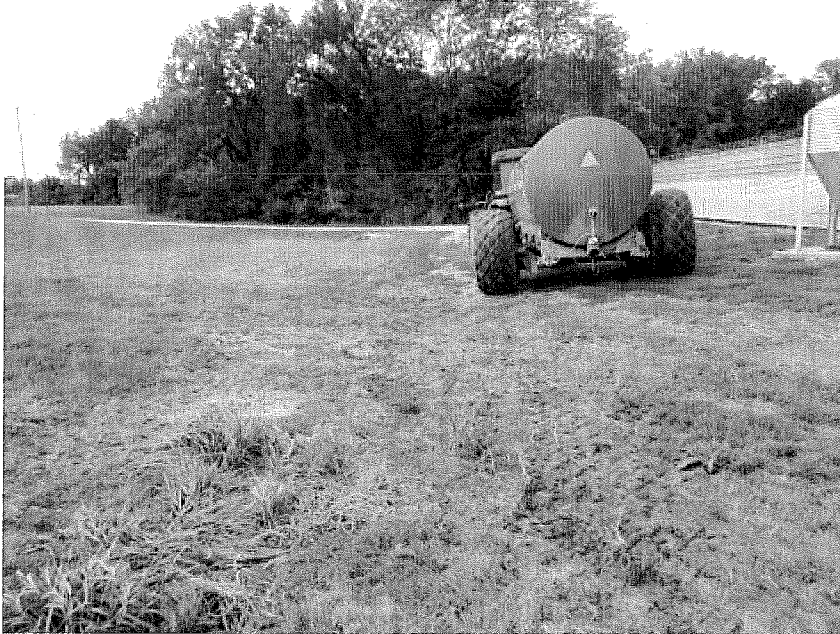
Location: In the yard south of Gestation Building E

IMGP1564: Storm water pathway in yard south of Gestation Building E passes through area of yard with manure solids around pump station.

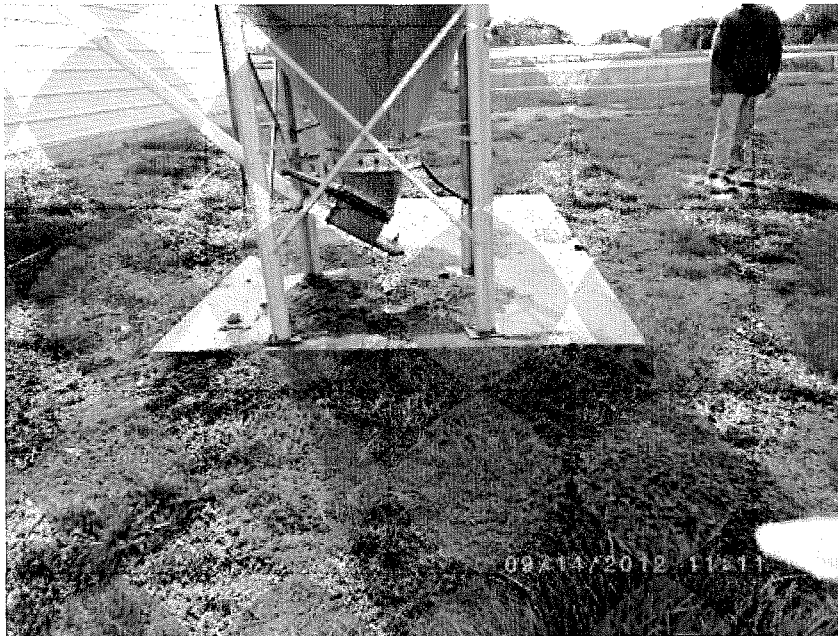
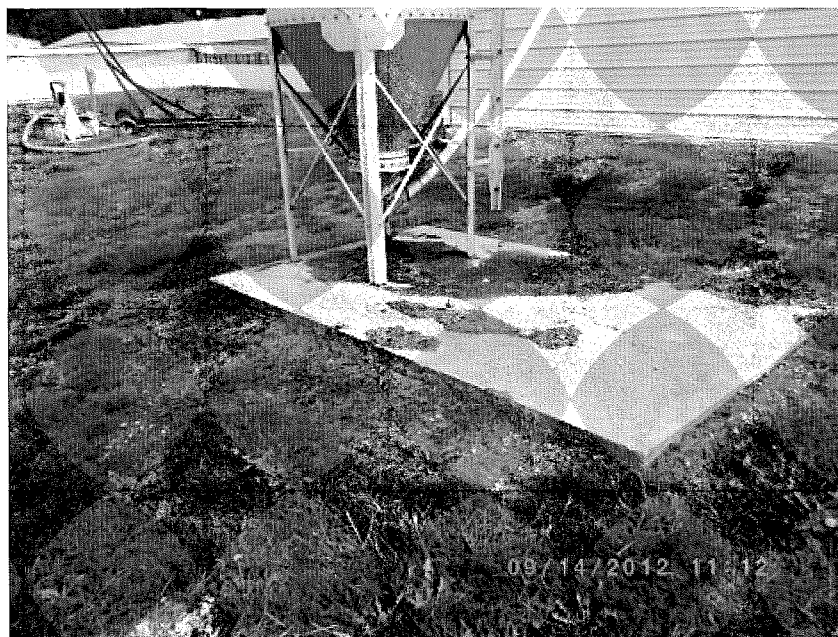
IMGP1568: Feed on ground under feed bin.  
 Location: In the yard west of the Nursery Building  
 Facing: South  
 Date/Time: 09/14/12 11:11 A.M.

IMGP1569: Feed on ground under feed bin.  
 Location: In the yard west of the Nursery Building  
 Facing: Northeast  
 Date/Time: 09/14/12 11:12 A.M.
